**Proceedings of the
OIPEEC Conference 2009 / 3rd International Stuttgart Ropedays**

J. van Rensburg¹, R. Rontgen¹, G. Rebel² and B. Schmitz²

Update concerning The premature discard of 45 mm ropes operating on a Blair multi-rope rock winder

Driefontein Gold Mine installed four 2500 m long 45 mm diameter round strand ropes on the No. 2 Shaft Blair Multi-Rope (BMR) Rock winder, located southwest of Johannesburg. The rope with eight compacted outer strands and a plastic coated steel core was selected for hoisting of ore in a 2043 m deep vertical shaft.

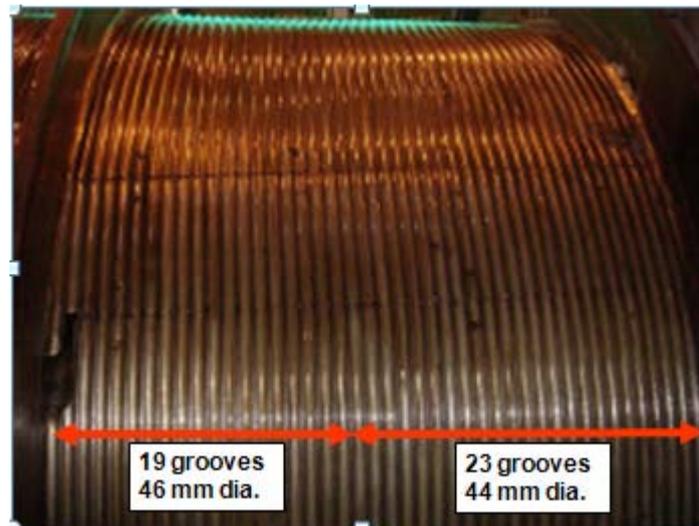
1. On rope installation concern was raised by the rope manufacturer about the LeBus sleeve sizes (Figure 7). The Industry SANS Code of Practice 10294 [1] recommends 47.7 to 48.6 mm for a 45 mm nominal diameter rope. The mine was notified on the 4th October 2005 of the problems associated with these reduced dimensions, namely that a severe reduction of rope life was expected. Details of this were shown in the previous paper [2].

Figure 7: Different groove diameters on the LeBus drum. The first 19 grooves from the hawse hole have a diameter of 46 mm, the remaining 23 grooves have a diameter of 44 mm.

As mentioned above, before the round strand rope only triangular strand ropes had been used on the Driefontein No 2 Shaft. Immediately after installation, these triangular strand ropes would unlay in the upper rope sections and thereby reduce their initial diameter from about 46 to 44 mm. Over the years, they wore down the 46 mm grooves to 44 mm.

This has never been a problem, because every new rope would again behave the same way. It only became a problem when for the first time a torsionally and radially much more stable rope design was installed. This new rope did not reduce in diameter immediately after installation and as a consequence did not fit into the 44 mm grooves.

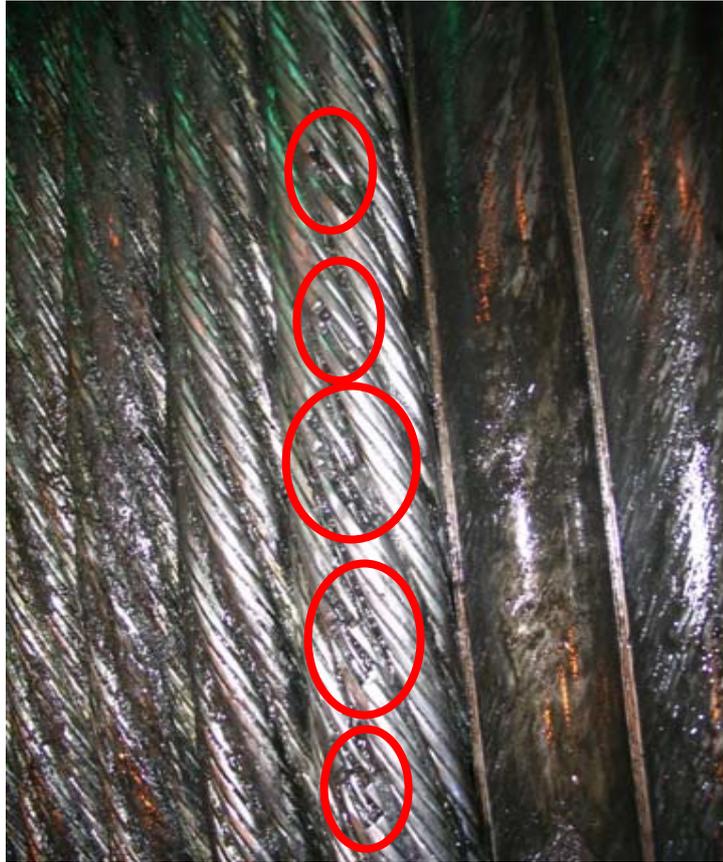
2. On 25th Oct 2005 a second magnetic rope test was done - no problems were found on the ropes.
3. On 3rd Dec 2005 the front and back-ends were cut.
4. On 24th January 2006 a third magnetic test was undertaken, the front and back-ends were cut.
5. On 14th March 2006 a fourth magnetic rope test was carried out. Again, no problems were found.
6. On 25th March 2006 the front and back-ends were cut.
7. On 4th April 2006 a fifth magnetic rope test was carried out. No problems were found.
8. On 30th May 2006 a sixth magnetic rope test was carried out. Numerous broken wires on different strands were found at the back-end on the left hand drum NE shaft compartment on both ropes (Figure 8). No 1 and 2 ropes were removed after 35,021 cycles and replaced with triangular ropes.

Figure 8: Numerous broken wires were found on different strands at the back-end of the rope.

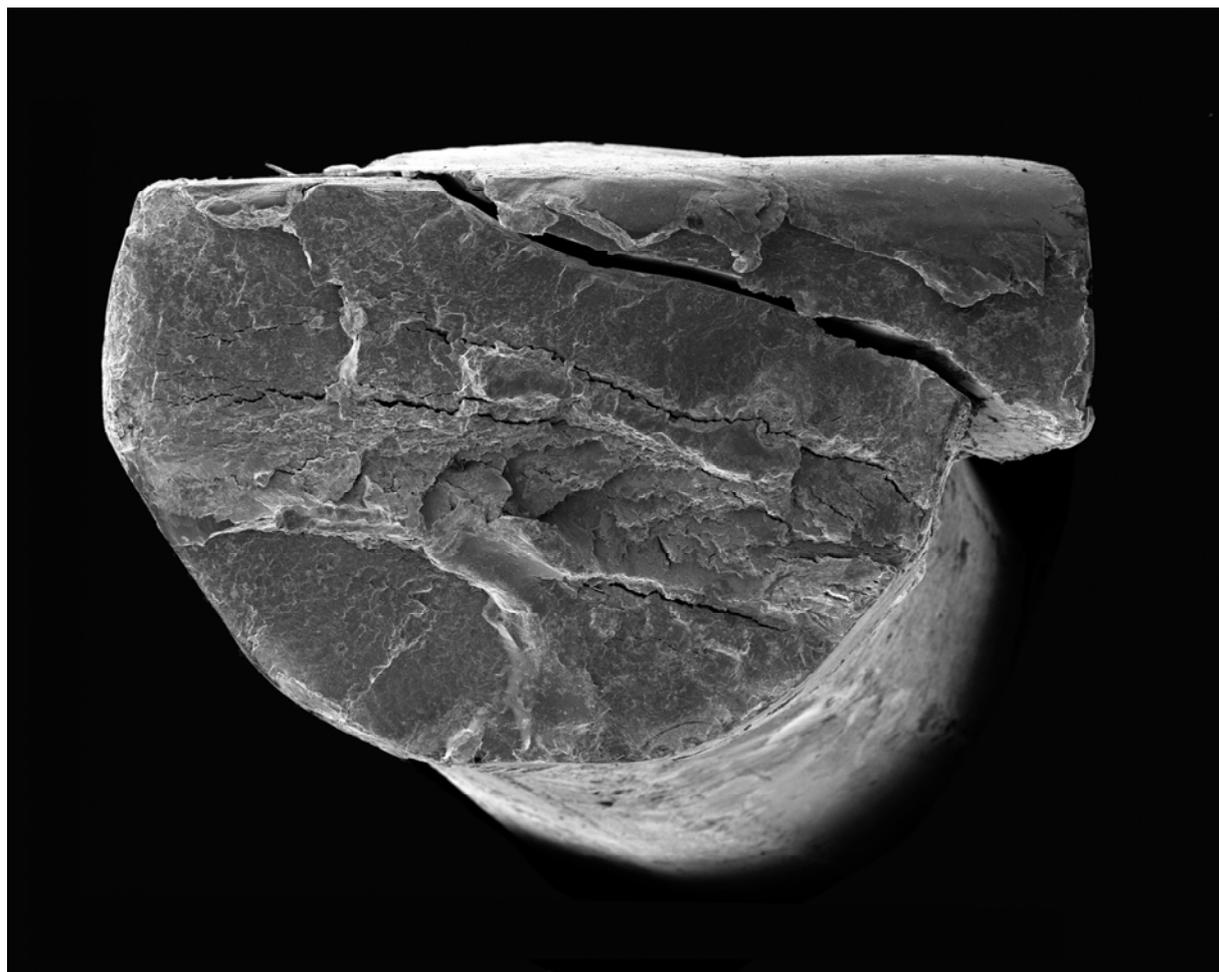
A typical wire break is shown in Figure 12. The top part of the wire has sheared off as a result of always being impacted in the same location.

Figure 12: Typical wire break in zone B/B. Magnification $\times 21$. SEM Photo © Wire Rope Technology Aachen.

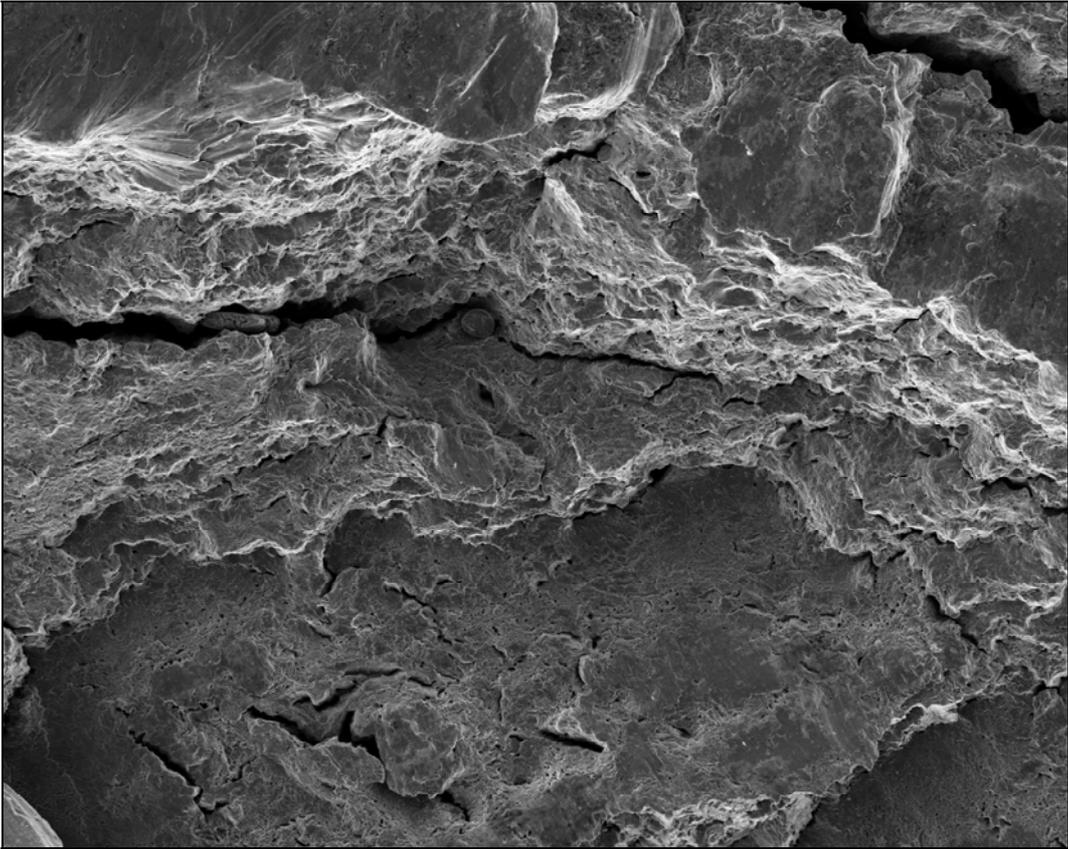
Figure 13 shows a detail of Figure 12 at a magnification of $\times 210$. At the point where the longitudinal crack changes direction, a round object can be seen.

Figure 13: Magnification $\times 210$. SEM Photo © Wire Rope Technology Aachen.

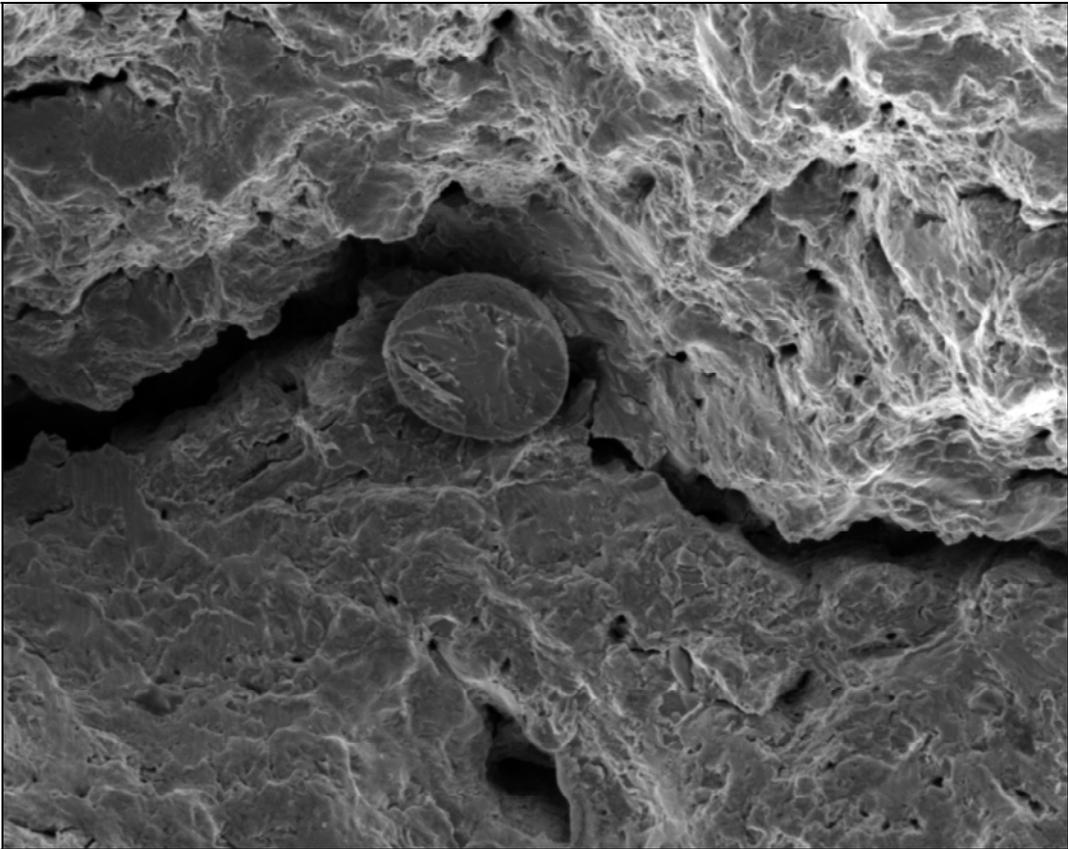
Figure 14 shows this object at high magnification (1200 times). The object turned out to be a manganese sulphide ball which can sometimes be found in rope wire. These balls have a melting temperature of more than 1600 °Celsius, are extremely hard and survive the wire drawing process without any deformation. This time, however, the repeated impact of the second rope layer hitting onto the first layer has split the ball right in the middle, revealing a break surface typical for a hard and brittle material. The split ball can be seen as a clear evidence of high impact forces acting on the rope wires.

Figure 14: Magnification $\times 1200$. SEM Photo © Wire Rope Technology Aachen.

In one of the wires, a very hard inclusion, a manganese sulphide ball, was found split in two by high impact forces.

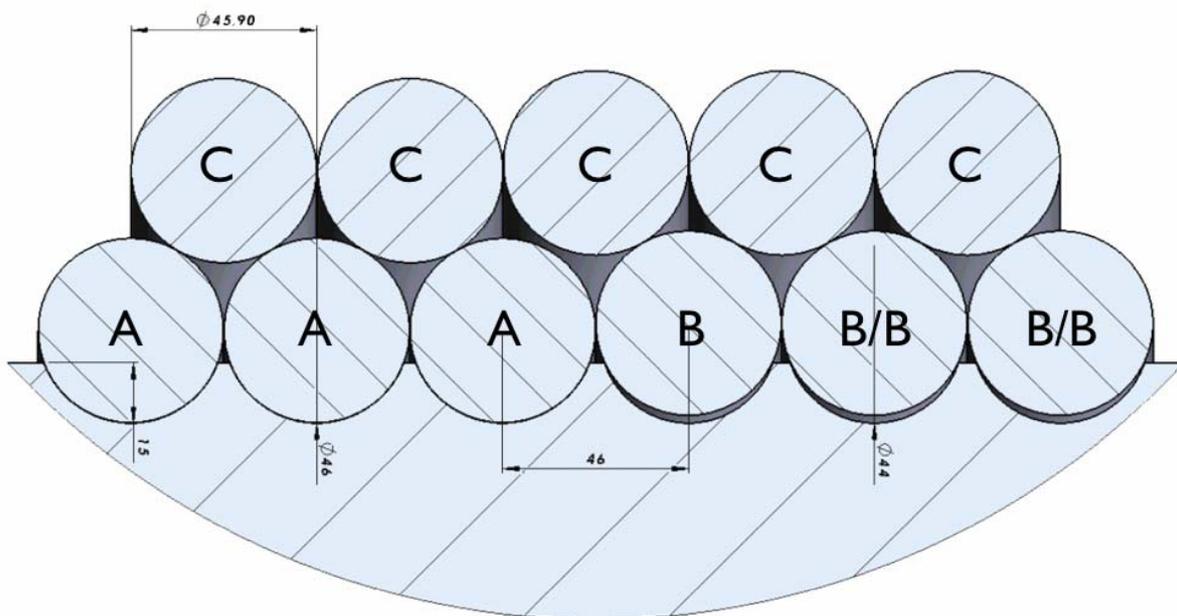
When this new rope was spooled onto the drum, it fitted into the 46 mm grooves in section A, but it did not fit into the 44 mm grooves in sections B and B/B (Figure 15). As a result, the rope would coil on a bigger drum diameter in sections B and B/B.

Figure 15: 46 mm grooves in section A and 44 mm grooves in sections B and B/B. The rope coils on a bigger drum diameter in sections B and B/B.

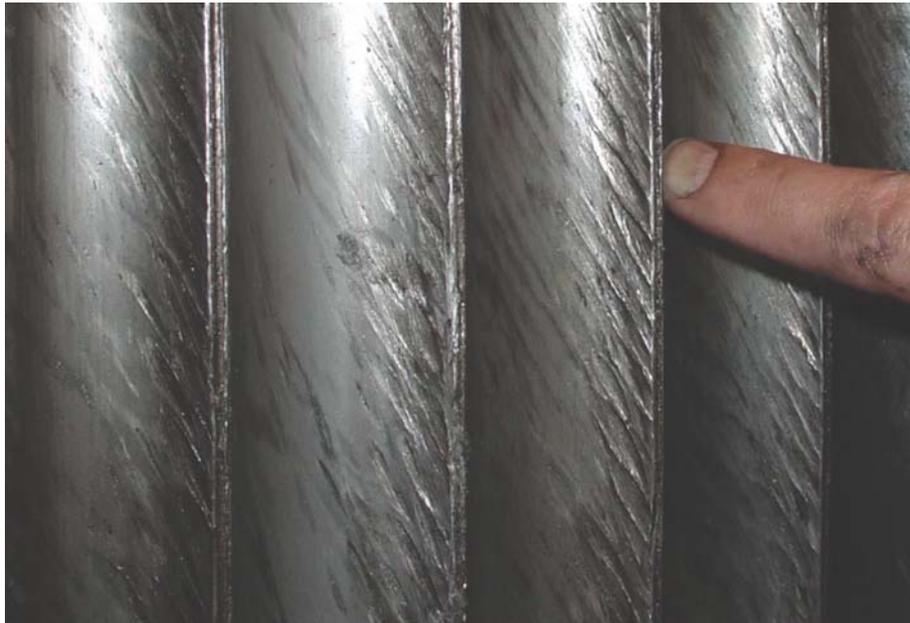
After climbing into the second layer, the rope would spool back over sections B/B and B, pressing the previous layer down into the groove, thereby damaging the drum grooves on one side (Figure 16) and creating a loss of pretension in the first layer by reducing the circumference.

This loss of pretension was milked forward via sections B/B and B into the dead turns in section A.

This mechanism leading to the loss of pretension in the first layer of the drum was identified as the second, and probably most important factor leading to the premature discard of the ropes.

Figure 16: Groove damage on one side – section B/B.

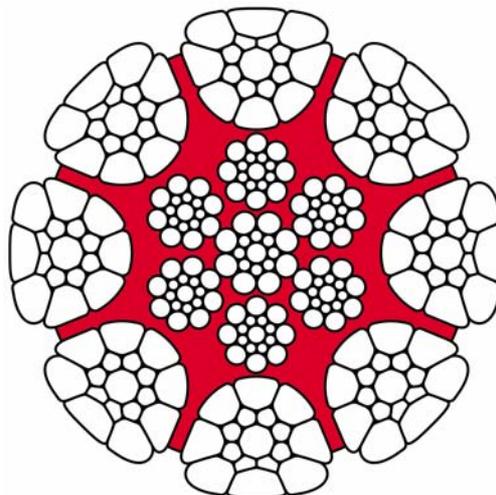
Figure 17: Swaged round strand rope with increased bearing area.

In order to combine the advantages of the two rope types it was decided to flatten the surface of the round strand ropes using a rotary swager, thereby increasing the bearing surface between two rope layers (Figure 17).

Ropes of such a design have already successfully been used in critical crane applications. Their improved geometry together with a revised maintenance programme will now help to increase the number of hoisting cycles also on the Driefontein No. 2 Shaft.
