ODN 0818

# A case study of 54 mm ropes operating on a double drum rock

#### winder

### Summary

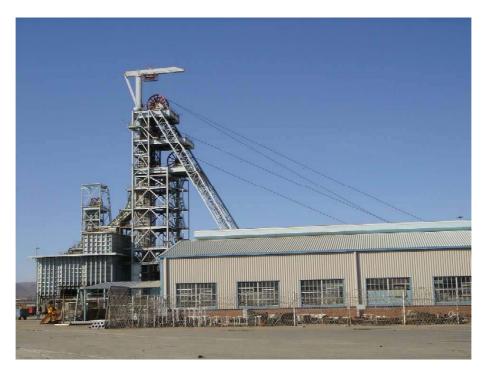
Figure 1: Karee No. 3 Main Shaft headgear, the top two ropes are the rock winder ropes.

The rock winder is a double drum installation at Lonmin Platinum Karee No. 3 Main Shaft. The shaft, headgear and the winders were commissioned in November 1992 and are responsible for hoisting circa 224,000 tonnes per month of platinum ore which represents 21 % of the Lonmin Platinum monthly production. The most important shaft data is shown in Table 1 below. Figure 1 shows the Karee No. 3 Main Shaft headgear and Figure 2 shows the rock winder. The headgear sheaves are fitted with plastic groove inserts as in Figure 3.

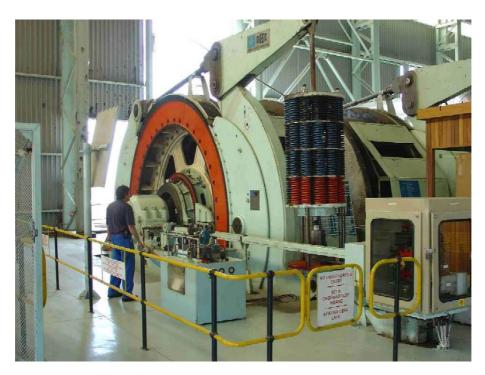
Figure 2: Karee No. 3 Main Shaft double drum rock winder.

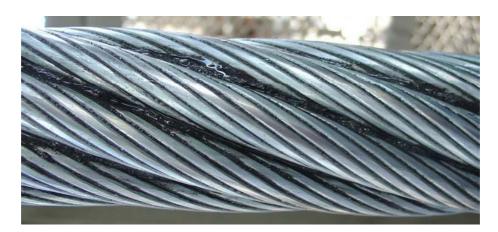
Figure 5b: Turboplast as-installed exterior.

The eight-strand design provides a round wire rope cross-section. The compacted Lang's lay outer strands provide superior abrasion resistance and smooth coiling performance on multilayer drums, Figure 5b.

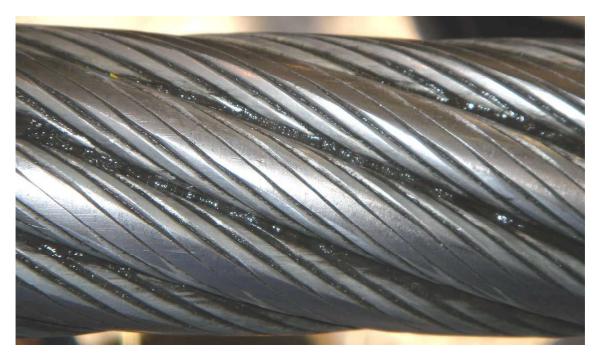
Figure 7: Typical layer crossover area plastic wear after circa 20,000 cycles.

Based on operating experience with eight-strand ropes in Australia on similar winders, the target number of cycles between backends was set at 30,000 (60,000 skips for the winder). Regular inspections of the turn and layer crossover regions were done at intervals of 10,000 cycles during the first six months of rope operation to ensure that damage was accumulating at the crossovers at the expected rate. Figure 7 shows a typical pattern of deterioration at the LeBus layer cross-over area after circa 20,000 cycles. This can be compared to the undamaged rope in Figure 5b.

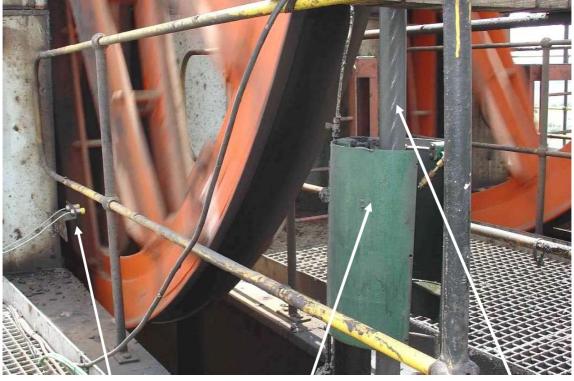
Rotation counter

Oil spray system

Rope

Figure 8: Permanent automatic rope lubrication system mounted in headgear, below the sheaves. This system was only used for the eight-strand ropes and not for the TSRs.

A key difference in the maintenance practices compared the previous triangular strand ropes was the installation of a fully automatic spray lubrication system. Figure 8 shows the arrangement of this below the headgear sheaves. A four nozzle spray arrangement was controlled based on the number of cycles completed by the ropes. The ropes were dosed with ELASKON Spray Oil 200 circa every 300 cycles over the operating rope length. The cost of the lubrication over the guaranteed life of the eight-strand ropes is given in Table 5 and has been taken into account in the cost benefit analysis. The use of the automatic spray lubrication system reduces shaft downtime and ensures that the correct amount of lubrication is always applied to the ropes. In the past, the triangular strand ropes were lubricated every two months with standard bitumen based wire rope dressing.
