**Proceedings of the
OIPEEC Conference 2009 / 3rd International Stuttgart Ropedays**

J. van Rensburg¹, R. Rontgen¹, G. Rebel² and B. Schmitz²

Update concerning The premature discard of 45 mm ropes operating on a Blair multi-rope rock winder

Driefontein Gold Mine installed four 2500 m long 45 mm diameter round strand ropes on the No. 2 Shaft Blair Multi-Rope (BMR) Rock winder, located southwest of Johannesburg. The rope with eight compacted outer strands and a plastic coated steel core was selected for hoisting of ore in a 2043 m deep vertical shaft.

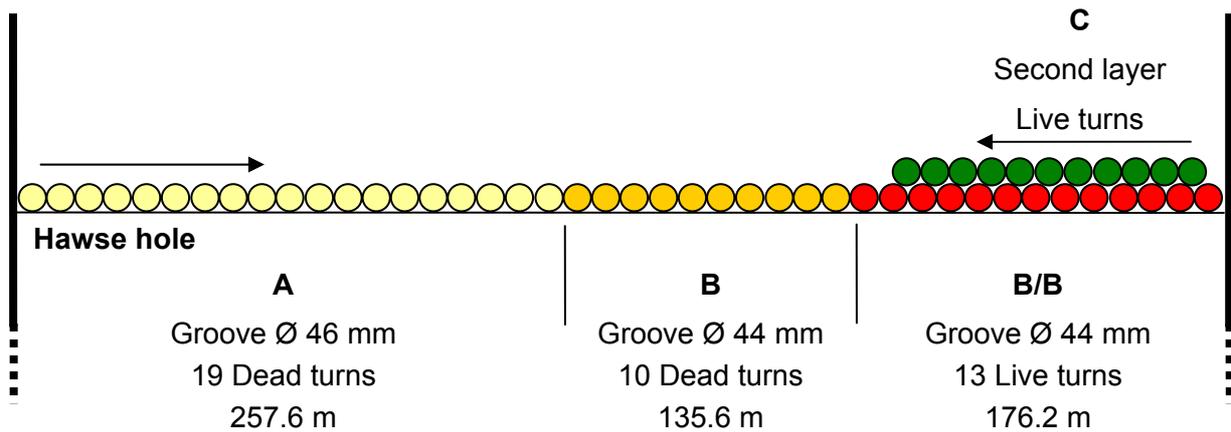
Samples “B/B” were taken from the live turns from the drum, B/B samples operated variously between the drum and over the head sheave and into the shaft (see Figure 10 below).

Samples “C” were taken from the second layer turns above B/B.

Figure 9: Discarded rope sections relative to drum coiling positions at rope installation.

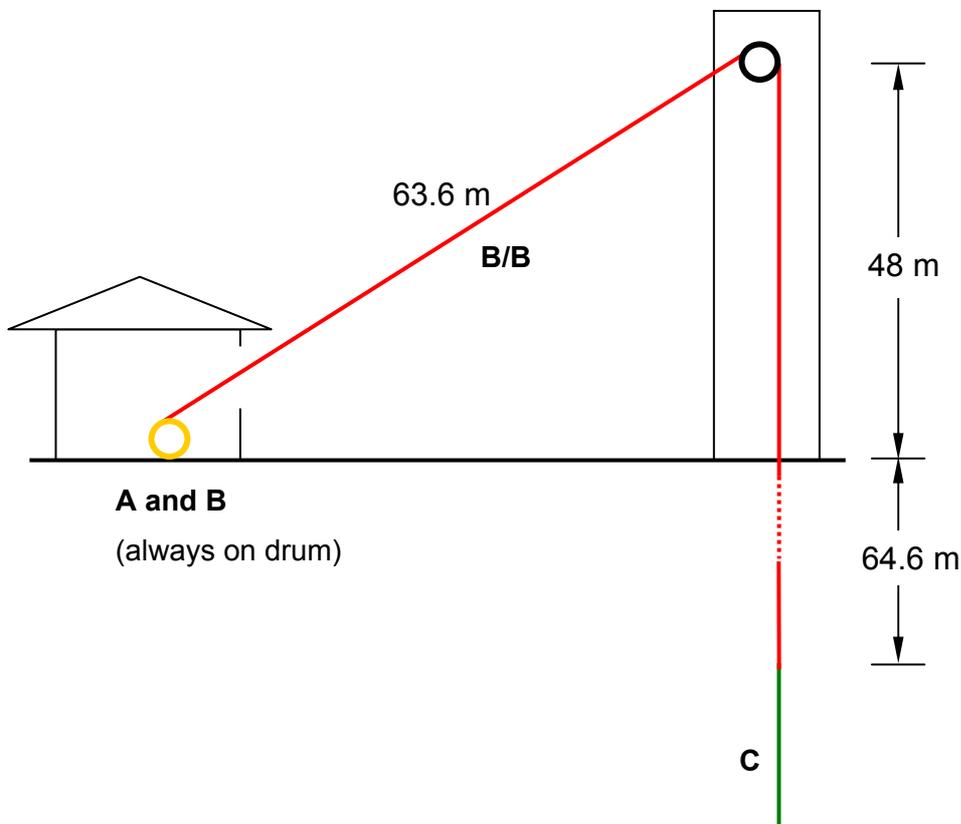
Figure 10: Rope sample positions relative to the BMR winder, headgear sheaves and mine shaft.
